# Experimental Investigation on Two Way RC Slabs with Textile Reinforced Mortar

Anjali P V<sup>1</sup>, Biju Mathew<sup>2</sup>

*1(Department of civil engineering, Vimal Jyothi Engineering college, Chemperi, Kannur, Kerala, India*

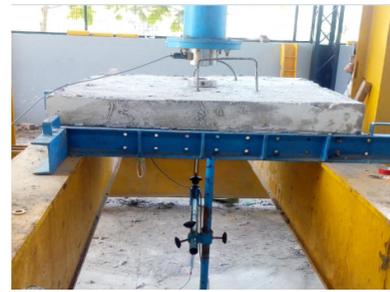
Fig 4 Test setup of specimen

All specimens were subjected to point loading and were tested as simply supported at their center. The test specimen was laid on rigid steel frame and the effective flexural span in both directions was 980 mm. The load was applied at a displacement rate of 1 mm/ min by using a 200 kN capacity hydraulic jack. For the better observation of the development of cracks all the specimen was white washed. The Linear variable differential transducers (LVDT) were placed at the bottom of the slab to measure the displacement of the test

specimen. The measured displacement will be displayed in the digital indicator and further it is connected to Data Acquisition system. After connecting this, the load is applied and continued until failure. A compression type load cell was used. The Fig.4 shows the test setup of specimen.
