IMPROVE THE HAZOP TECHNIQUES TO PREVENT THE ACCIDENTS CAUSED BY PRESSURE VESSELS

T. Sri Ananda Atreya
M.E. Industrial Safety Engineering
Excel college of Engineering and Technology
Erode, India

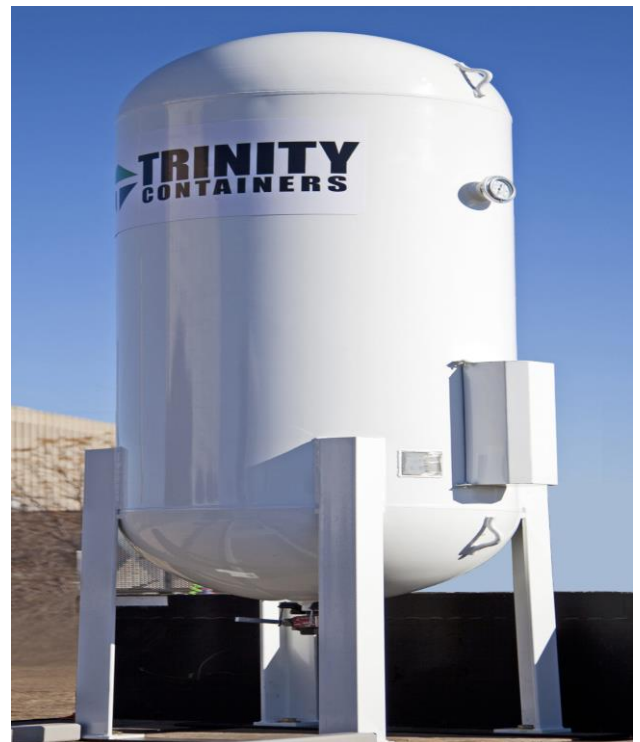
Fig.2. Vertical Pressure Vessel

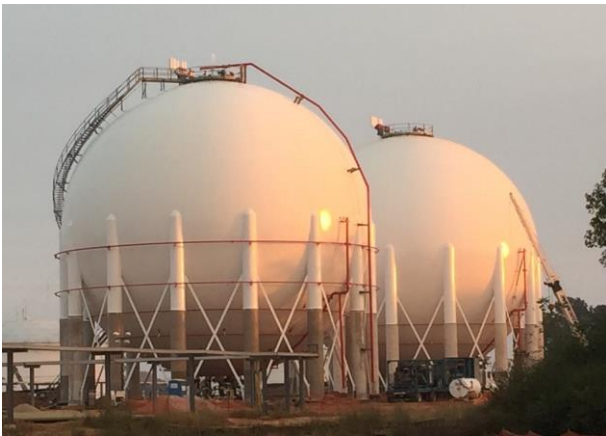
Fig.3. Spherical Pressure Vessel

This type of vessel is preferred for storage of high pressure fluids. A sphere is a very strong structure. The even distribution of stresses on the sphere's surfaces, both internally and externally, generally means that there are no weak points. Spheres however, are much more costly to manufacture than cylindrical vessels. Storage Spheres need ancillary equipment similar to tank storage - e.g. Access manholes, Pressure / Vacuum vent that is set to prevent venting loss from boiling and breathing loss from daily temperature or barometric pressure changes, Access ladders, Earthing points, etc. An advantage of spherical storage vessels is, that they have a smaller surface area per unit volume than any other shape of vessel. This means, that the quantity of heat transferred from warmer surroundings to the liquid in the sphere, will be less than that for cylindrical or rectangular storage vessels.

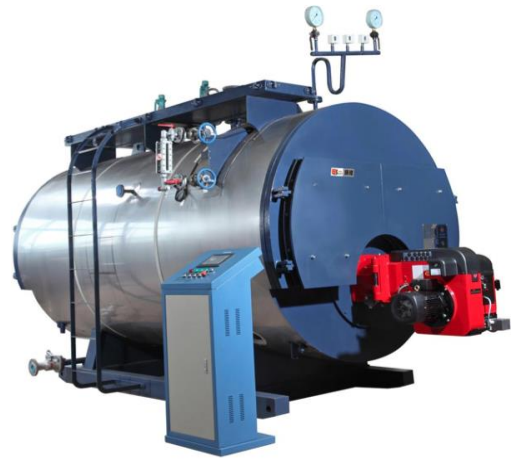
Fig.4. Steam Boiler

A pressure vessel is a tank designed to hold fluids (gases or liquids or both) at a high pressure without bursting. A boiler is a tank to hold a liquid (often water) so that it can be boiled by a heat source. Often the purpose is to produce steam under pressure to power something (such as a turbine to generate electricity or to propel a steam engine train). Boilers often have to withstand high pressure, in which case they would also be considered a pressure vessel. But it's possible that a boiler is just there to create hot water or steam at normal atmospheric pressure and the fluid is moved from the boiler out along some pipes by a pump. This could, for example, be part of a heating system for a building. In most cases a boiler would be designed to withstand pressure.

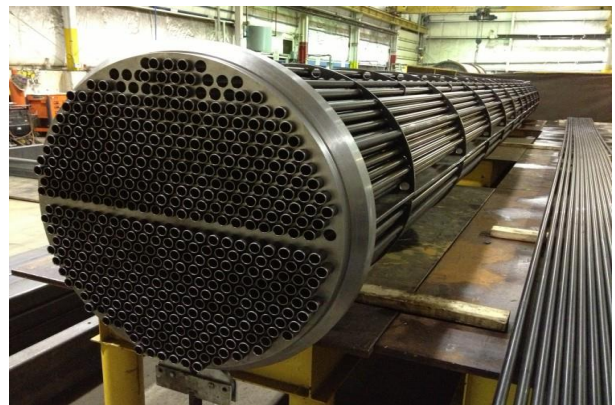
Fig.5. Heat Exchanger

The second most common type, and almost as prolific as storage vessels, is the heat exchanger. Found in almost every aspect of life, from food service to industrial plants, heat exchangers make modern processing and manufacturing possible. It is widely known that heat, by its very nature, can be a negative aspect to many industrial processes and as such has to be removed or reused to provide for this concern. Thus it is critical that any heat exchanger design have an emphasis on the material chosen to ensure that the vessel can be operated at peak optimization for extended periods. Carbon steel is a common material but usually more stringent alloys are used to ensure longevity and proper functioning.

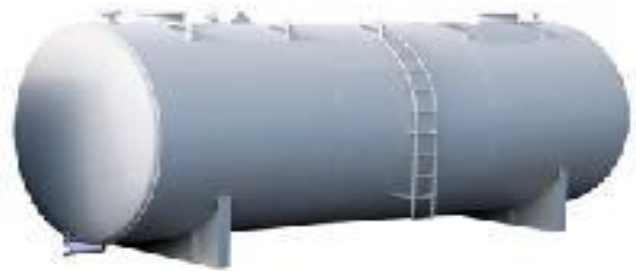
Fig.6. Saddle support

- Horizontal drums are typically supported at two locations by saddle support.
- It spreads over a large area of the shell to prevent an excessive local stress in the shell at support point.

- One saddle support is anchored whereas the other is free to permit unstrained longitudinal thermal expansion of the drum.

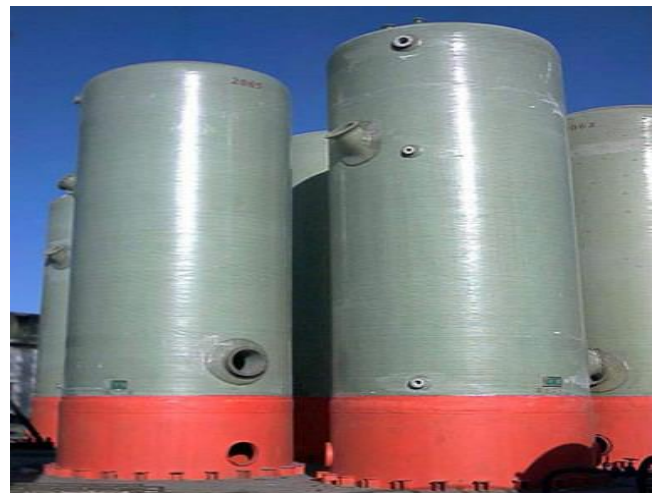
Fig.7. Skirt support

- Tall vertical cylindrical pressure vessels are typically supported by skirts.
- A support skirt is a cylindrical shell section that is welded either to the lower portion of the vessel shell or to the bottom head (for cylindrical vessels).
- The skirt is normally long enough to provide enough flexibility so that radial thermal expansion of the shell does not cause high thermal stresses at its junction with the skirt.

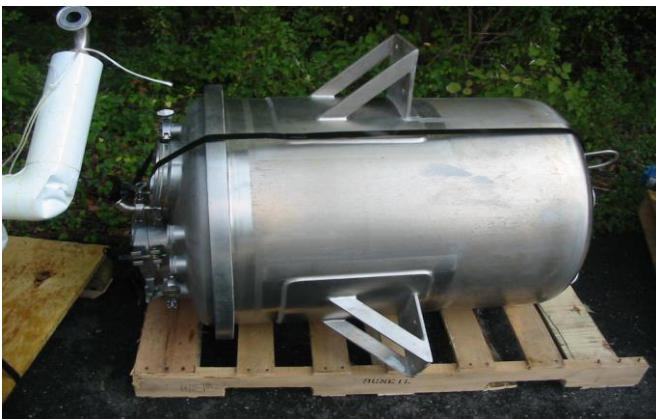
Fig.9. Lug support

- Vertical pressure vessels may also be supported by lugs.
- The use of lugs is typically limited to pressure vessels of small and medium diameter (1 to 10 ft)
- Also moderate height to diameter ratios in the range of 2:1 to 5:1
- The lugs are typically bolted to horizontal structural members in order to provide stability against overturning loads.

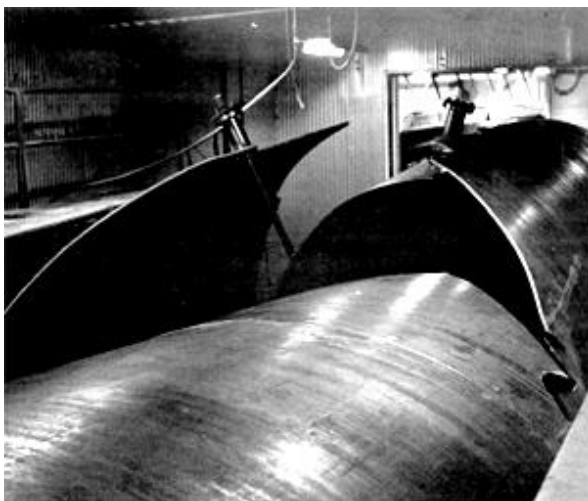
Fig.10. Welded joint failure

The faulty design is a common source for defects such as hard inclusions, blisters by trapped gas and micro-cracks that developed during fast cooling of the welded joint. Present rules in fabrication codes are aimed to reduce the probability of failures in pressure vessels subjected to cyclic pressure or vibrations.

Reactor pressure vessels (RPV) and pipelines are commonly constructed using welded pressure vessel grade steels and stainless steel liners. These pressure vessel steels required good ductility and weld-ability. The vessels wall materials used in oil refineries and chemical plants undergoes both physical and chemical changes because of various separation and conversion processes. These steel vessels operate in corrosive and high temperature environments. The operating temperature typically ranges from -29 to 427 °C.

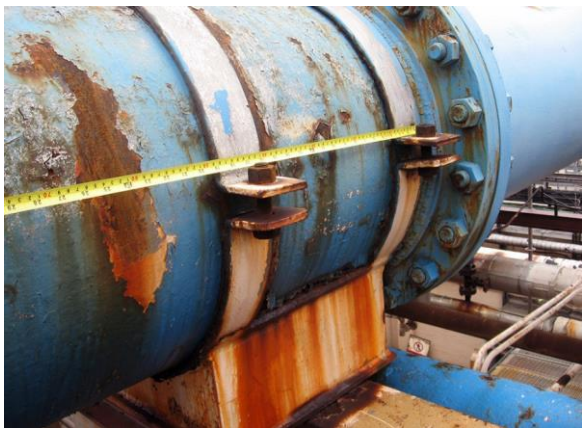
Fig.11. Failure due to corrosion and cracking

Local attack on the other hand is more of an enemy to designers. Stress concentrations are produced at pits; grooves and notches start to form; and ultimately cracks cut through the weakest point of the vessel.

Corrosion and stress are actually interacting together and locally corroded metal experiences more stresses under normal pressure. And in return when the metal becomes more stressed, it corrodes faster. This combined action creates a vicious cycle that brings to sudden rupture and must be avoided at any cost.

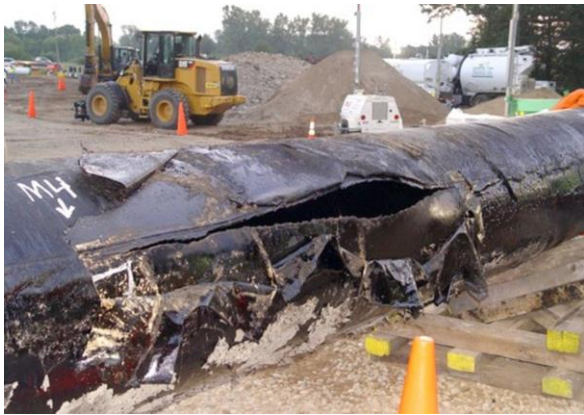
Fig.12. Failure due to use of poor quality of materials

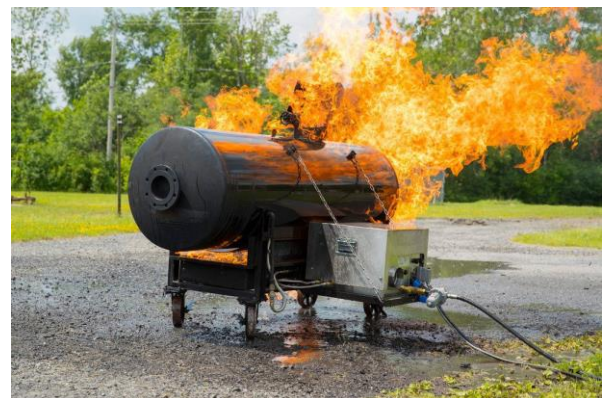
Fig.13. Failure due to excessive temperature

Design temperature is the temperature that will be maintained in the metal of the part of the vessel being considered for the specified operation of the vessel. For most vessels, it is the temperature that corresponds to the design pressure. However, there is a maximum design temperature and a minimum design temperature (MDMT) for any given vessel. The MDMT shall be the lowest temperature expected in service or the lowest allowable temperature as calculated for the individual parts. Design temperature for vessels under external pressure shall not exceed the maximum temperatures.

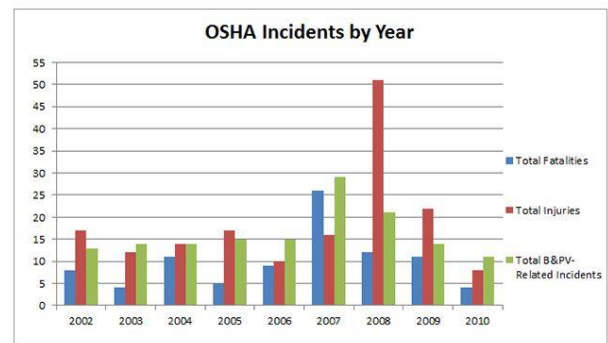
Fig.14. Rate of accidents

The study of history shows that the maximum number of accidents took place because of improper maintenance and wrong operations. Around 6 fatal accidents involving a huge number of fatalities and casualties took place in between 1966-2018. National Board of Boiler and Pressure Vessel Inspectors recorded the number of accidents involving pressure vessels at an increase of 24% over the course of a year between 1999 and 2000.

These Accidents includes pressure vessel, high water heating boilers, steam boilers, unfired pressure vessel.
